**NEW HARDENED DEFENSIVE POSITIONS,  
CHORWON VALLEY, NORTH KOREA**

**SEPTEMBER 1973**

**PIR-038/73**

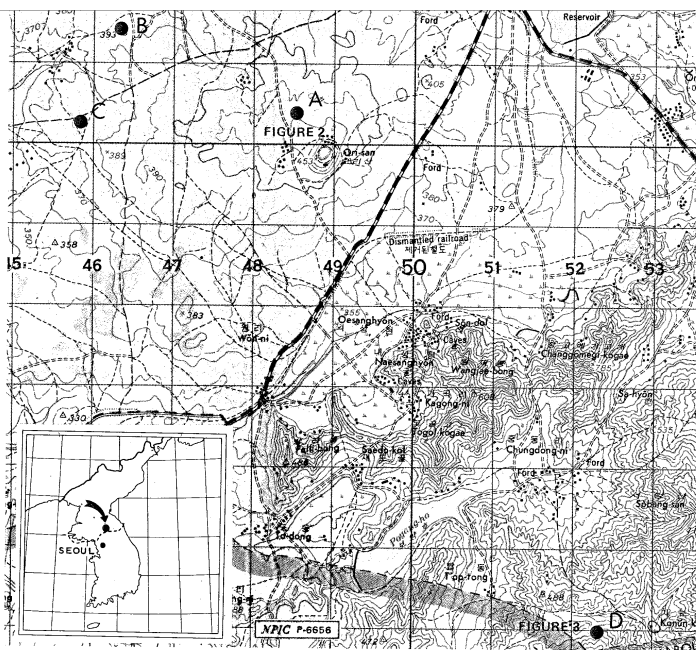
FIGURE 1. LOCATIONS OF NEWLY IDENTIFIED DEFENSIVE POSITIONS UNDER CONSTRUCTION

1. Four hardened fortifications were newly identified under construction in the Chorwon Valley in North Korea on photography of July 1973 (Figure 1). Three of the fortifications (items A-C, Figure 1) appear identical and consist of two connected Y-shaped concrete structures (Figure 2). The fourth fortification (item D) appears to be a concrete-covered trench system (Figure 3).

2. The Y-shaped structures are being built in the center of the Chorwon Valley at 38-23-30N 127-15-47E (item A), 38-24-00N 127-14-20E (item B), and 38-23-30N 127-13-56E (item C). The covered trench system is being constructed on the reverse slope of a ridge at 38-20-10N 127-18-40E.
